Deutsches Institut
für Feuerfest und
Keramik GmbH

Rotary Kiln Test

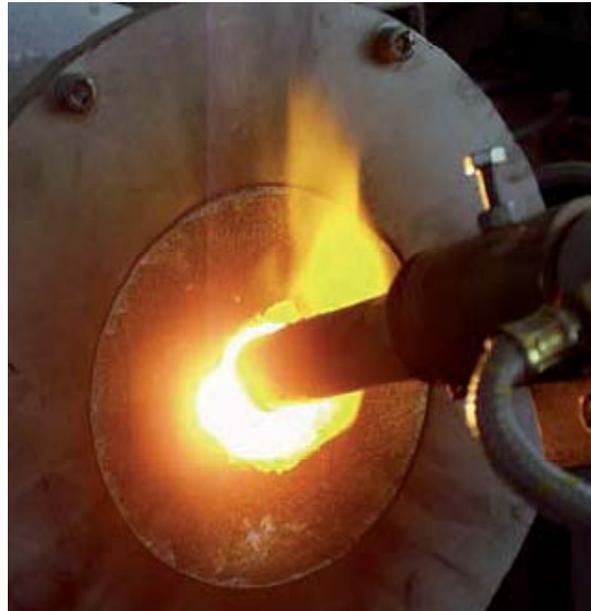
In the furnace used by DIFK GmbH eight segments of four different refractory materials are arranged in such a way in pairs, that an octogon crucible (26 cm bore x 24 cm) is obtained. The joints are free of mortar. The rotary kiln is rotating 2 - 10 times/min. A gas-burner is heating up the furnace up to 1750 °C and melts the steel and slag as well.

Fig. 1: Rotary kiln test

Fig. 1 shows the furnace in operation and Fig. 2 its pouring.

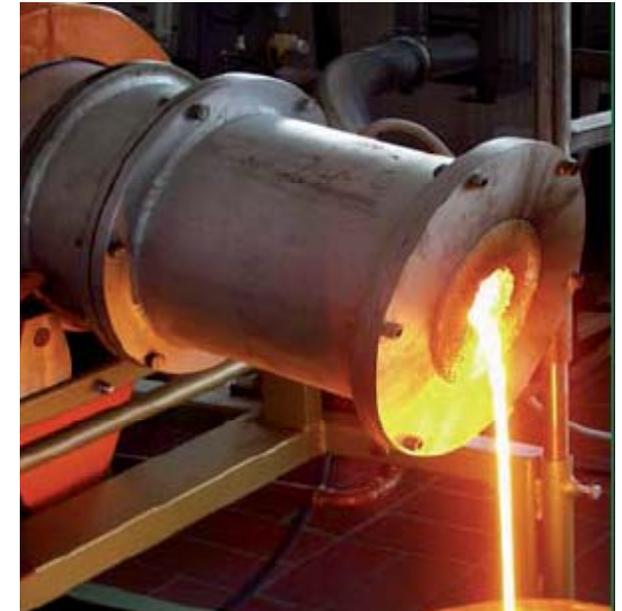
Fig. 2: Pouring
